# FLOOD PLAIN INFORMATION

## PIKE CREEK

NEW CASTLE COUNTY,  
DELAWARE.

PREPARED FOR NEW CASTLE COUNTY DEPARTMENT OF PLANNING BY THE  
DEPARTMENT OF THE ARMY, PHILADELPHIA DISTRICT, CORPS OF ENGINEERS,  
PHILADELPHIA, PA.

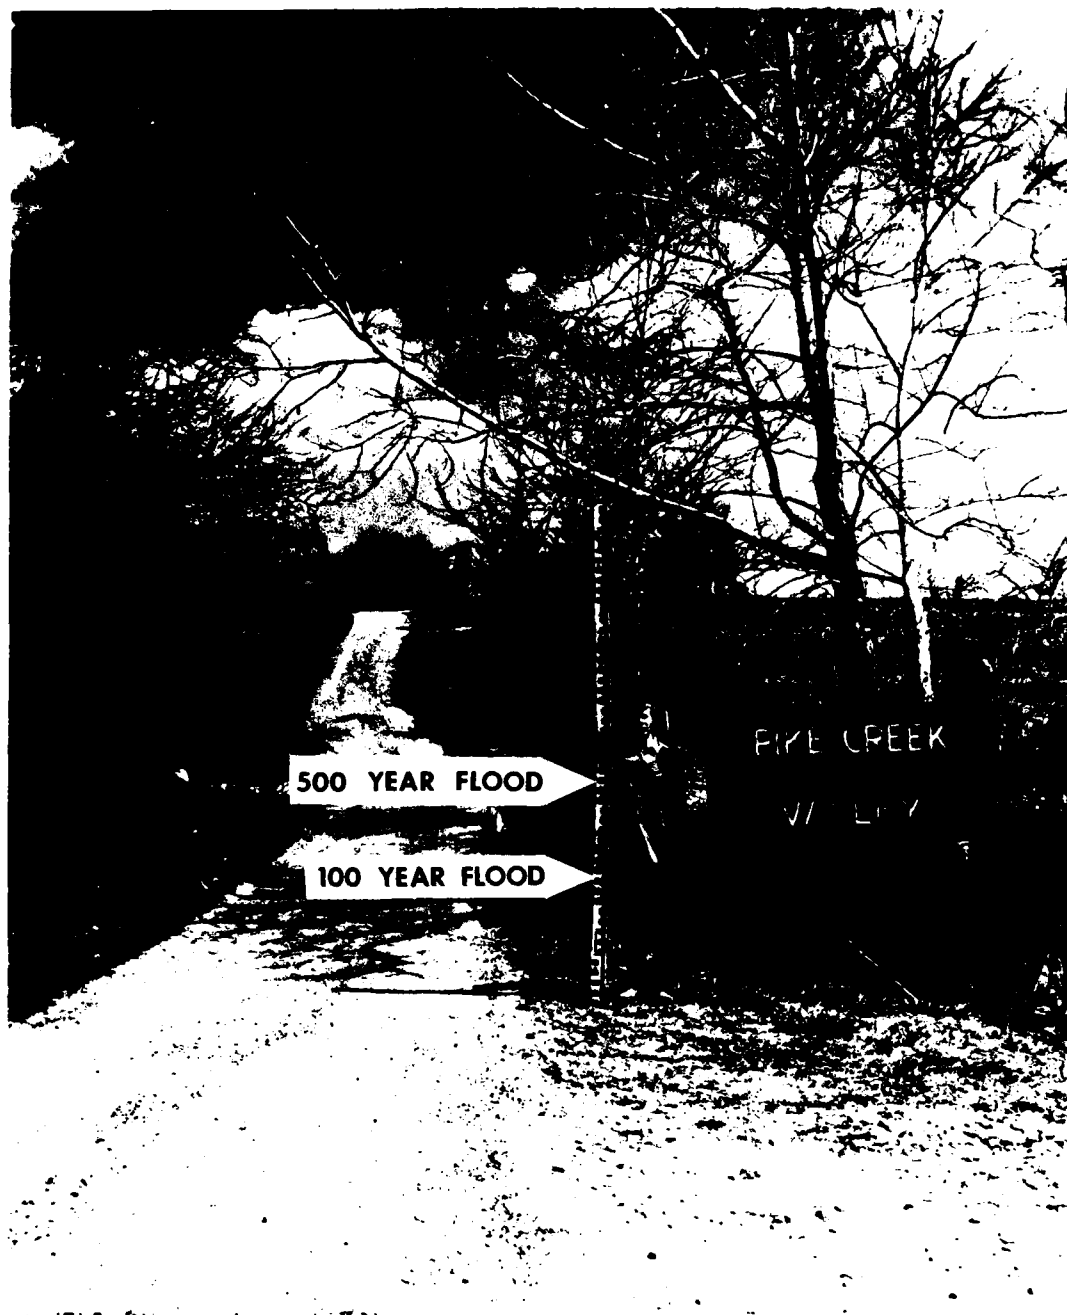
**FIGURE 1** - Possible future flood heights at a Private Road Bridge (Mile 3.02) over Pike Creek.

**Photographs, possible future flood heights** — The levels that the 100-Year and 500-Year Floods are expected to reach at various locations along Pike Creek are indicated on the following photographs.

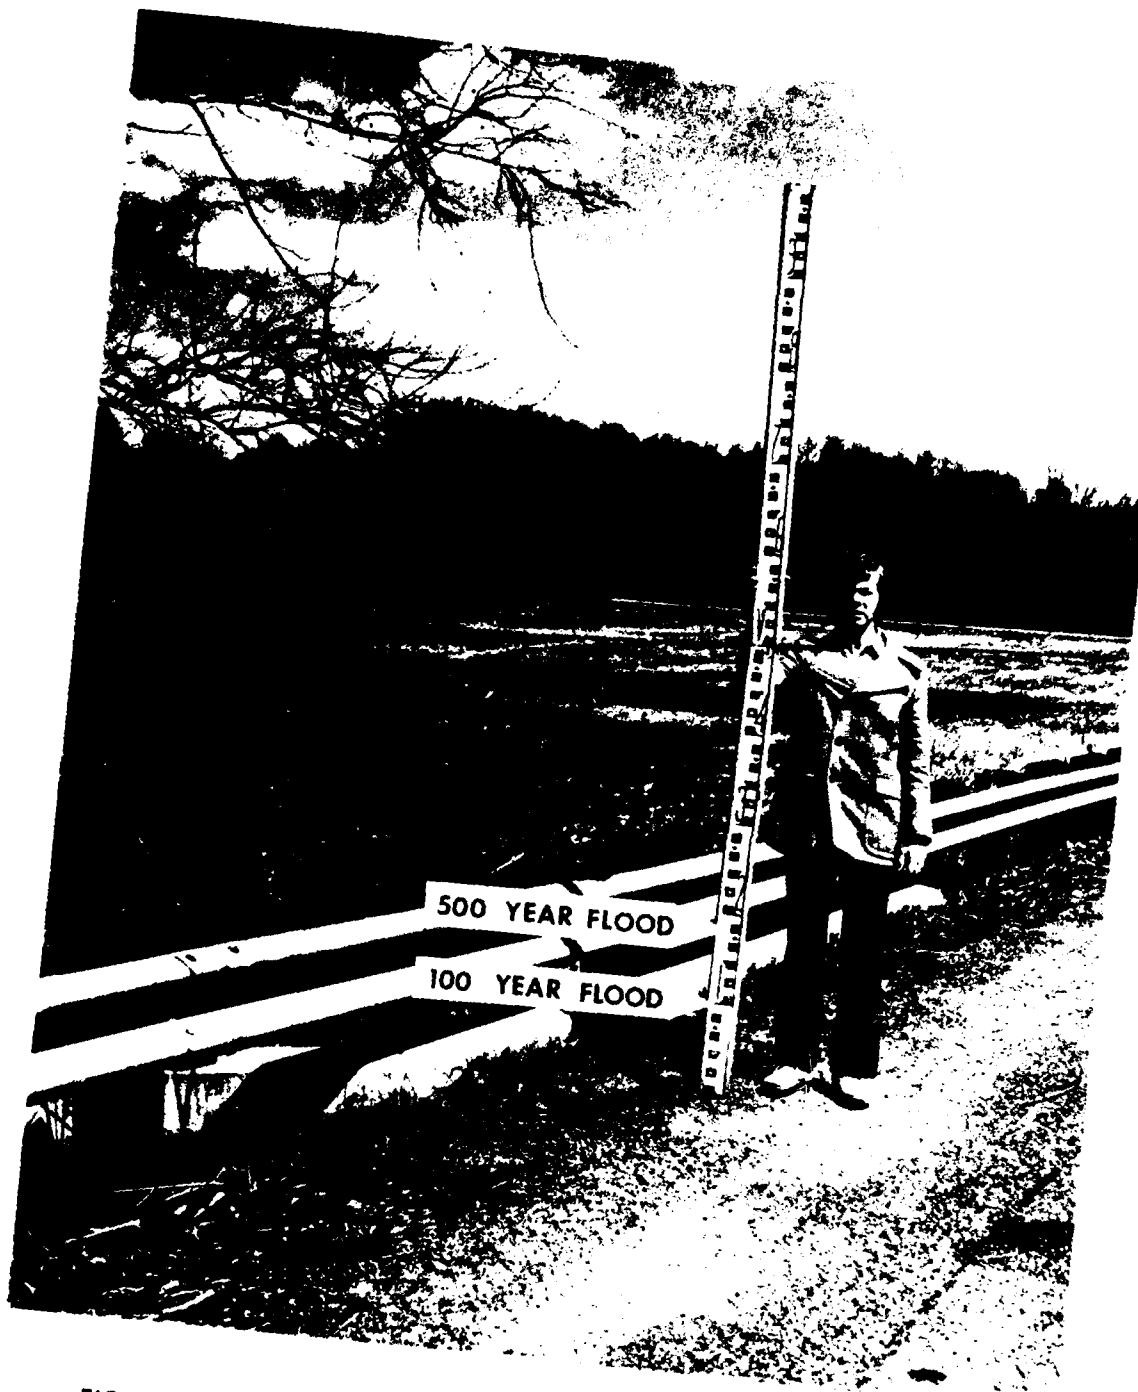
FIGURE 3 - Possible future flood heights at the Delaware Route 72 Bridge over Pike Creek.
